Environmental risk associated to mining activity Colbu 1 and 2 tailings ponds, Baia Borsa, Romania

Dan COSTIN, Alexandra-Iulia COZMA, Raluca-Ioana UTIU

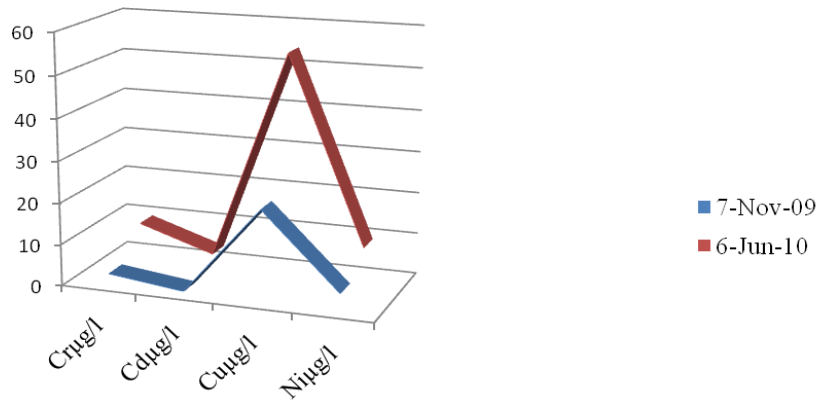
River Cisca

■ We can observe that on the river Cisca the analysis from 6 June 2010 are more **higher** than 7 November 2009, especially in the case of Cu.

■ Cisca river was found as leveling the **5th water quality class**.

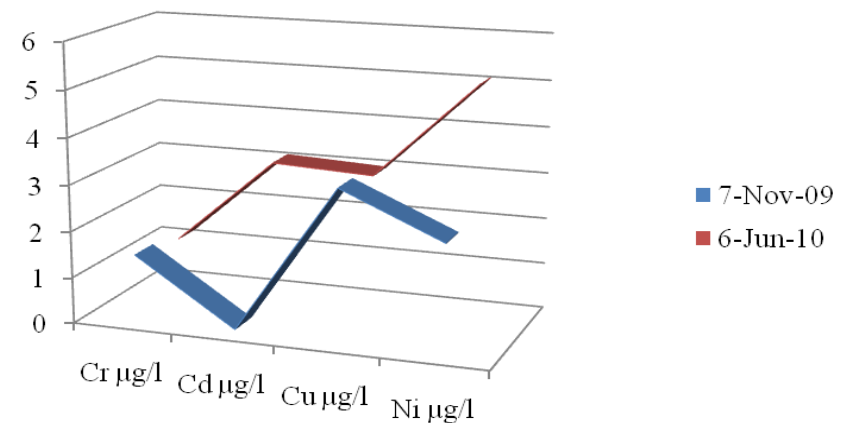
River Colbu

Unfortunately at Colbu river the concentrations of Cd and Ni are very higher in 6 June 2010.

One the other hand the **pH** of Waters in **under 7**, another serious problem for tailings dam.
