MINING RISK ASSESSMENTS – VALEA SESEI TAILINGS POND, ROSIA POIENI, ROMANIA

Dan COSTIN, Alexandra-Iulia COZMA, Raluca-Ioana UTIU

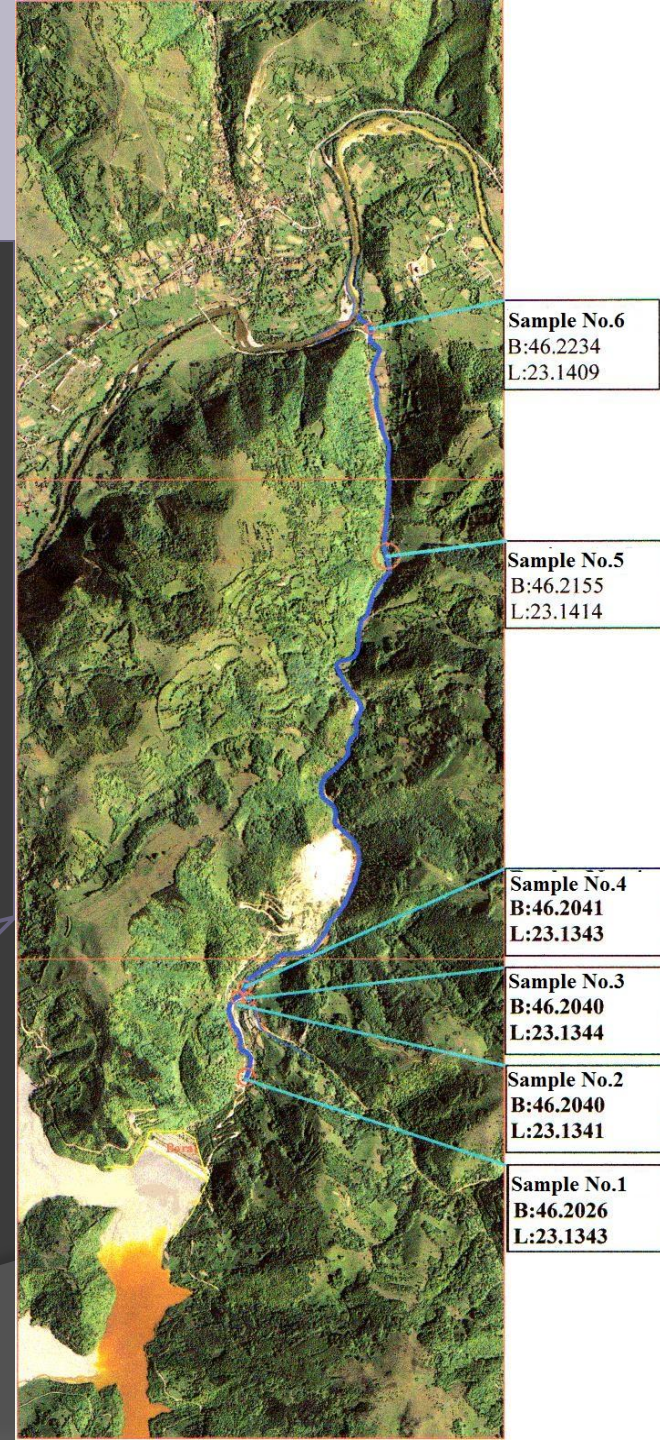
- 1. water exit from the spillway channel ;
- 2. the Sesei valley upstream from the confluence with Little valley;
- 3. Little valley;
- 4. the Sesei valley downstream of the confluence with Little valley;
- 5. the Sesei valley about 1.5 km to the confluence with Aries river;
- 6. the Sesei valley 200 m upstream of the confluence with Aries river.

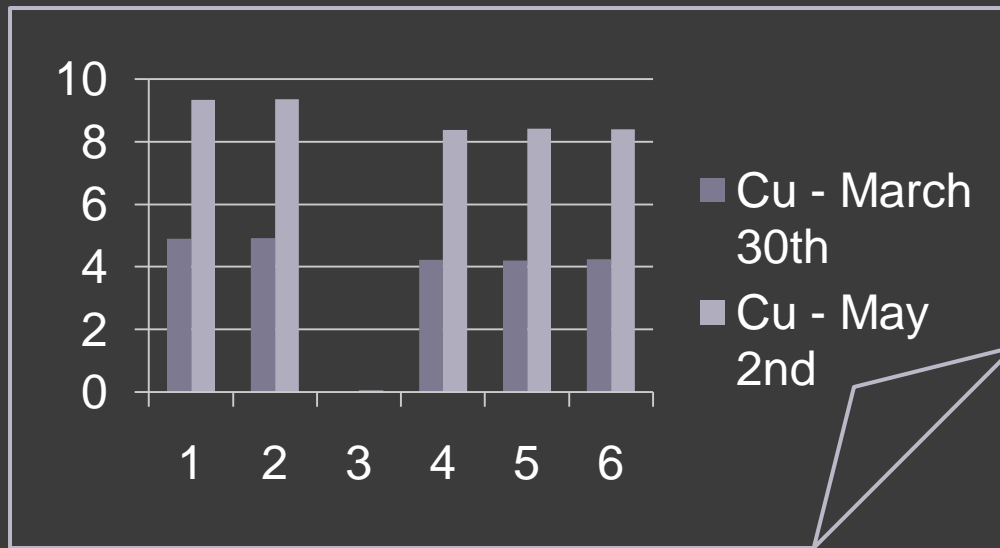
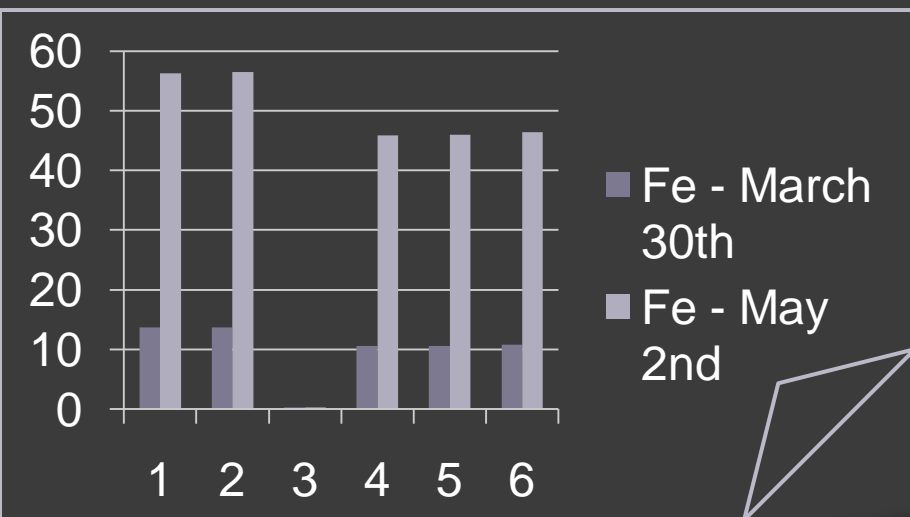
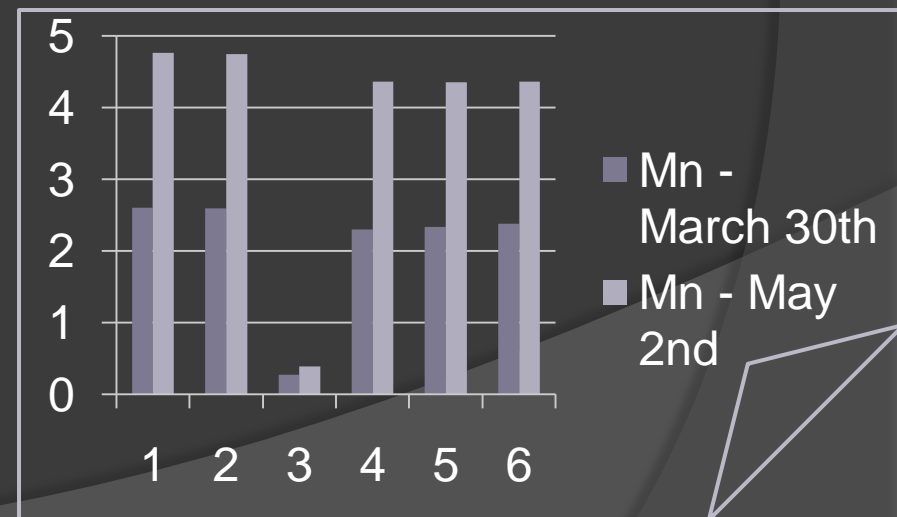
Results and discussions

- weather conditions can have some influence on concentrations of heavy metals, however it can be seen in the graphs that there is a correlation between samples analyzed in reducing concentrations in the two dates, even if weather conditions were different.

Although water quality in the Sesei Valley is degraded, its impact on water quality of Aries is quite low it considering that there is a difference between the two flow rates sufficient to achieve water with a better dilution and so a better water quality.
